# **Applied Testing of Airdar's Air Detection and Ranging System**

**Prepared for  
Airdar Inc.**

**February 2024  
F472-TR-1-Rev1**

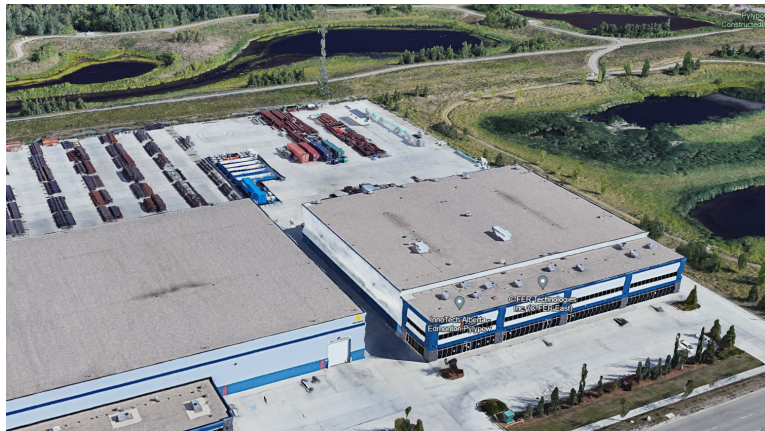
**Figure 2.1 Google Earth Image of C-FER's Pylypow Location (1)**

The System was set up in C-FER's yard at their Pylypow location. A Google Earth image of the facility is shown in Figure 2.1. The yard is 80 m (262 ft) wide by 100 m (328 ft) long and is fenced on three sides, with the building on the fourth side. The Pylypow constructed wetlands are to the north and east of the yard. The wetlands consist of storm ponds and grasses with few trees to obstruct the wind. To the west there is a neighbouring facility with pipes in the yard, and on the south side of the yard is C-FER's building. Along the east fence there is standard 120VAC power.

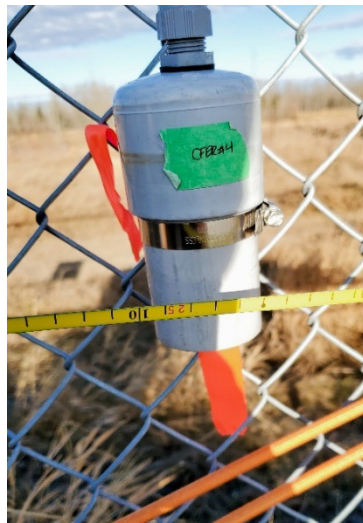
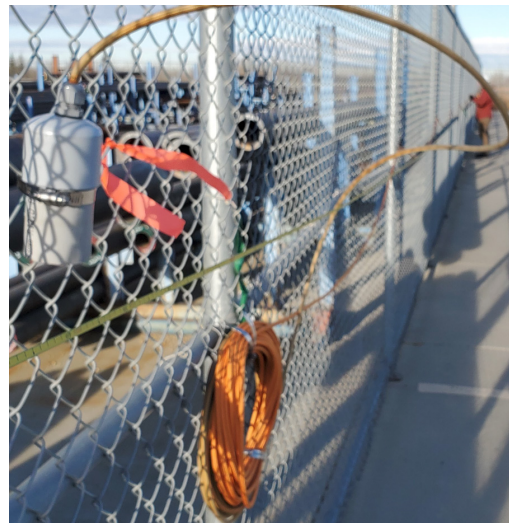
**Figure 2.3 Photographs of Sensor Inlet 4**

The System was placed along the east fence, and tubing was run along the fence line to seven sampling locations (shown in Figure 2.2). Photographs of the sampling location inlets are shown in Figure 2.3. The lengths of tubing running to each sensor location were the same to allow all sensor inlets to have equal transport time through the tubes to the System. The excess lengths were coiled, as seen in Figure 2.3b.

**a) Sensor Inlet 4**

**b) Sensor Inlet 4 (with Coil of Excess Tubing Length)**

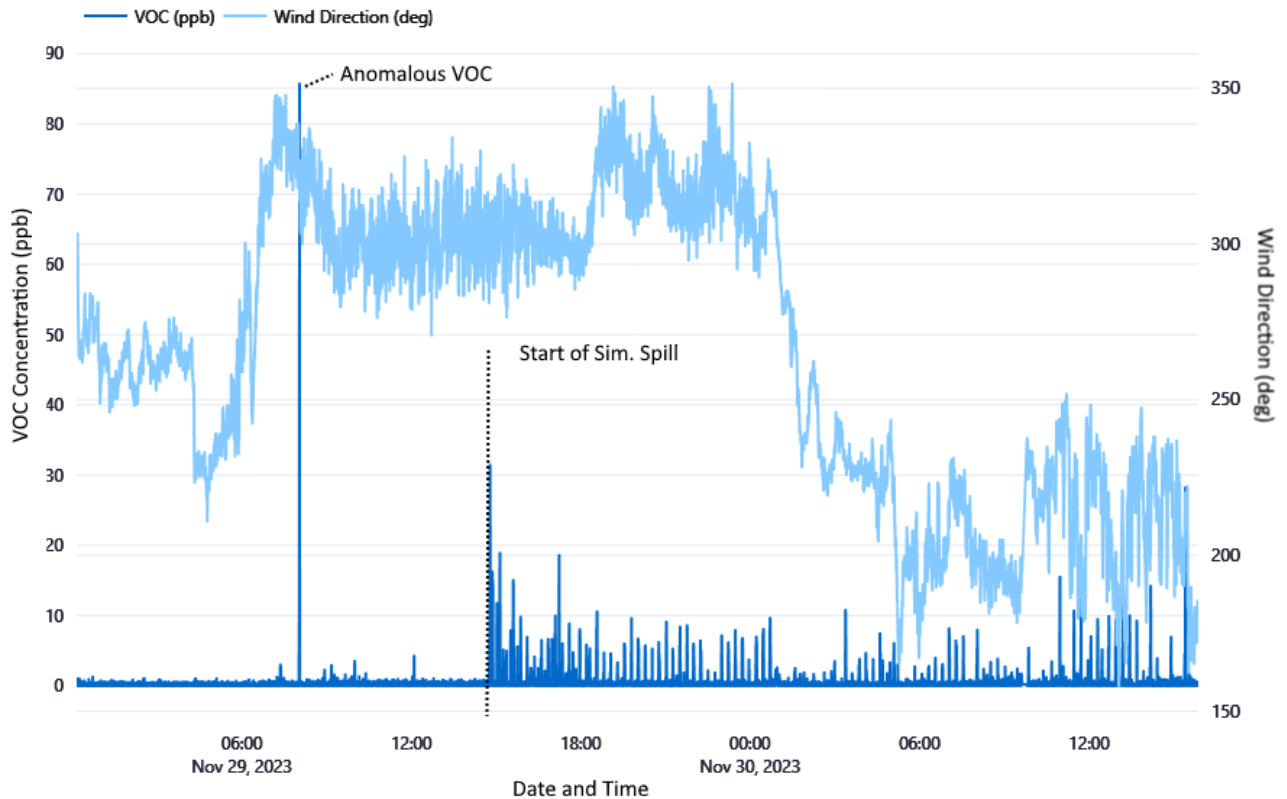
**Figure 3.1 Test 1: VOC Concentrations and Wind Conditions (from Airdar Client Dashboard)**

Figure 3.1 shows an image from the Airdar Client Dashboard showing the VOC concentration and wind direction over the course of the test. The VOC concentrations increased considerably, relative to the baseline, approximately 2 minutes after the simulated spill was introduced, with an initial

peak of approximately 32 ppb. The peak concentrations then dropped to between 5 and 10 ppb for much of the test duration.

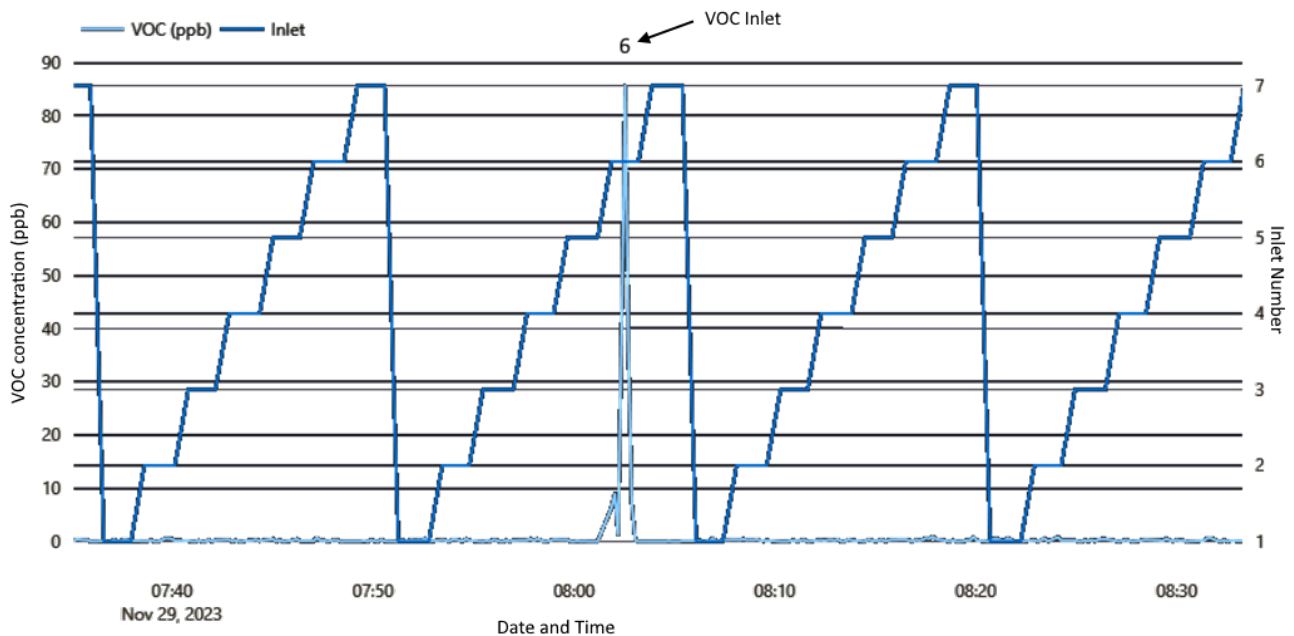
**Figure 3.4 Test 1: VOC Concentrations and Inlet Number at Anomalous Spike Prior to Spill (from Airdar Client Dashboard)**

There was also an anomalous, short duration (1 sampling cycle) increase in VOC concentration observed at 8:02 AM the morning of the test. Figure 3.4 shows the VOC concentration (86 ppb) and inlet number (Inlet 6) during this anomalous spike. Inlet 6 was located along the west fence, and the wind direction was from 320° (NE), as shown in Figure 3.1, indicating that this was from a source offsite. It is suspected that there was activity in the neighbouring yard, resulting in a short duration VOC release; however, this could not be confirmed. The System did not flag this as a potential leak and was able to determine that this was an offsite source without issue.

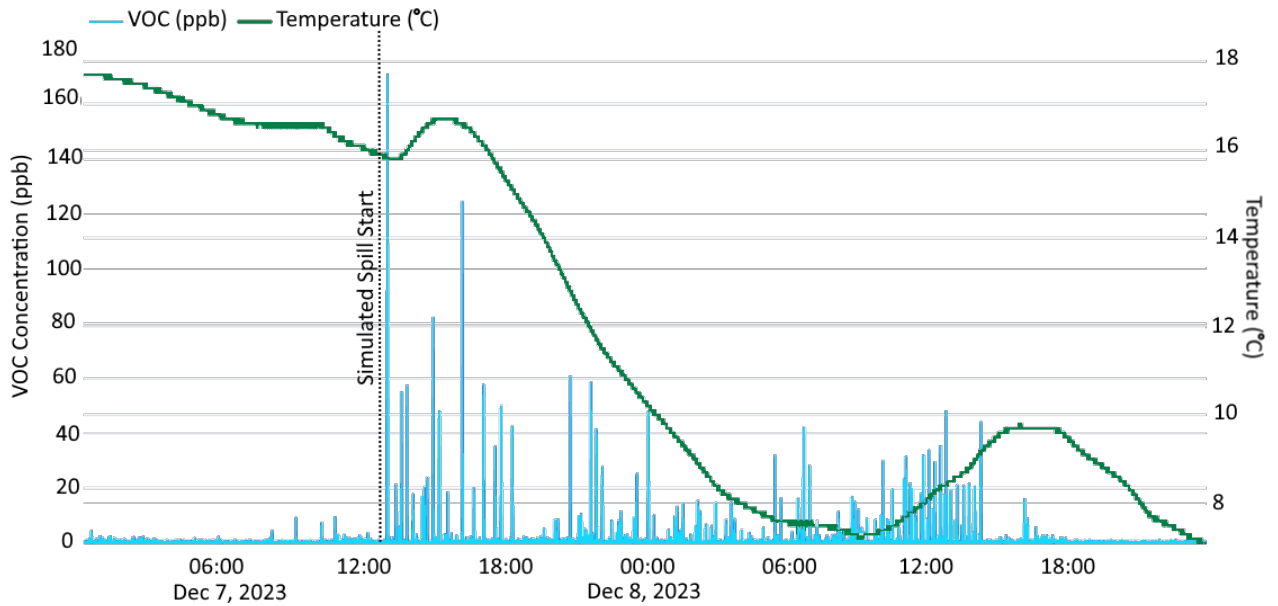
**Figure 3.5 Test 2: VOC and Temperature**

The VOC responses from the System are shown along with the air temperature in Figure 3.5. The System recorded a response 6 minutes after the start of the spill. This corresponds to the first sample from Inlet 2, which was located downwind from the spill location. Figure 3.6 shows the concentrations and wind directions during the start of this test. The peak concentration reached was 170 ppb at the start of the test, and then it dropped to between 5 and 45 ppb for the duration of the test. At the start of the test, the wind was coming from approximately 300°, placing Inlets 2

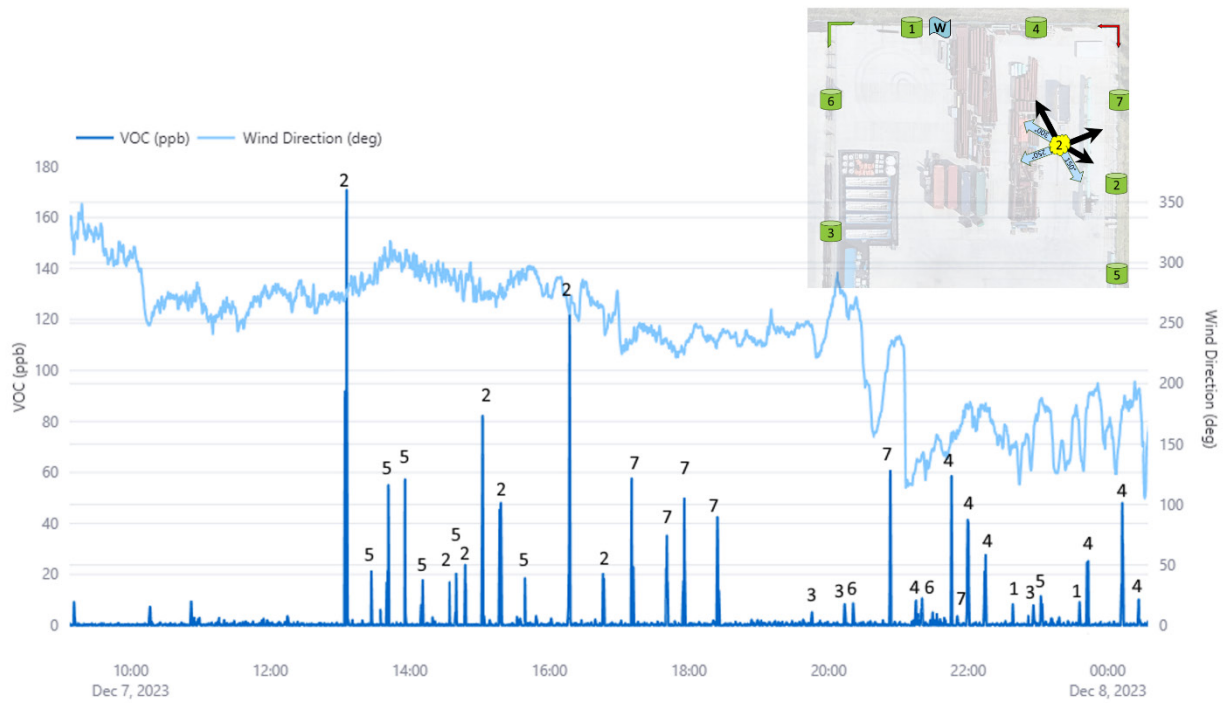
**Figure 3.6 Test 2: VOC and Wind Conditions with Sensor Inlet Numbers and Inset Map of Sensor Locations at Start Time**

and 5 directly downwind. After a few hours, the wind shifted to approximately 250°, resulting in Inlet 7 recording increased VOC levels. The wind then fluctuated between approximately 100° and 200°, which led to intermittent VOC level increases at Inlets 1 and 4 to the north, 6 to the west and 7 to the east.

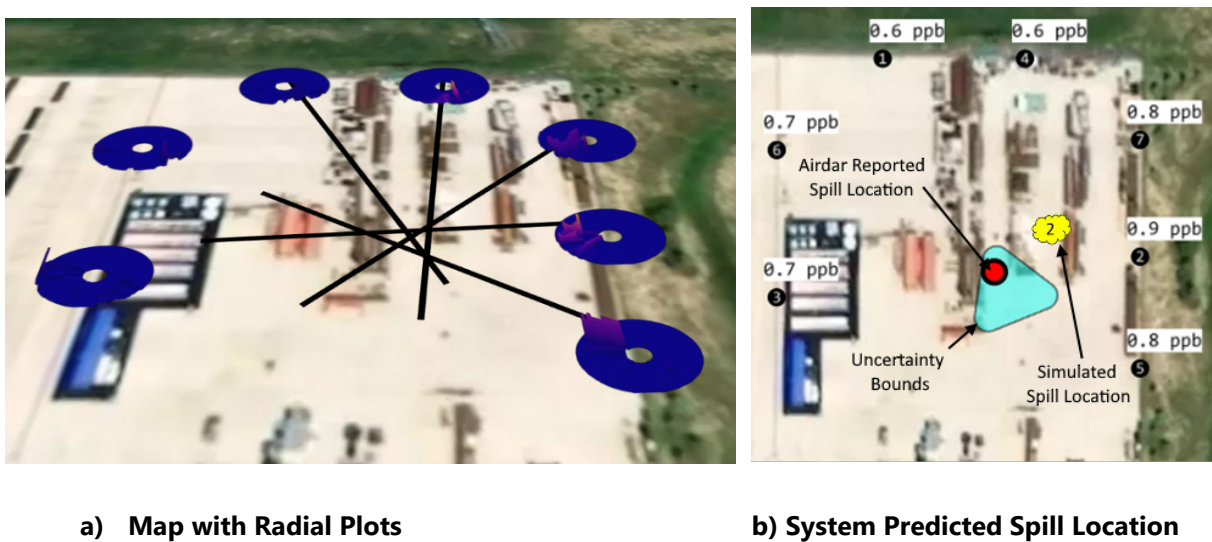
**Figure 3.8 System-predicted Spill Location**

Figure 3.8 shows the simulated spill location as predicted by Airdar (approximately 18 m from the actual location), along with an area of uncertainty based on the amount of available data. The positional error is likely due to the effect that the buildings and other equipment in the area had on the path of the wind within the yard.

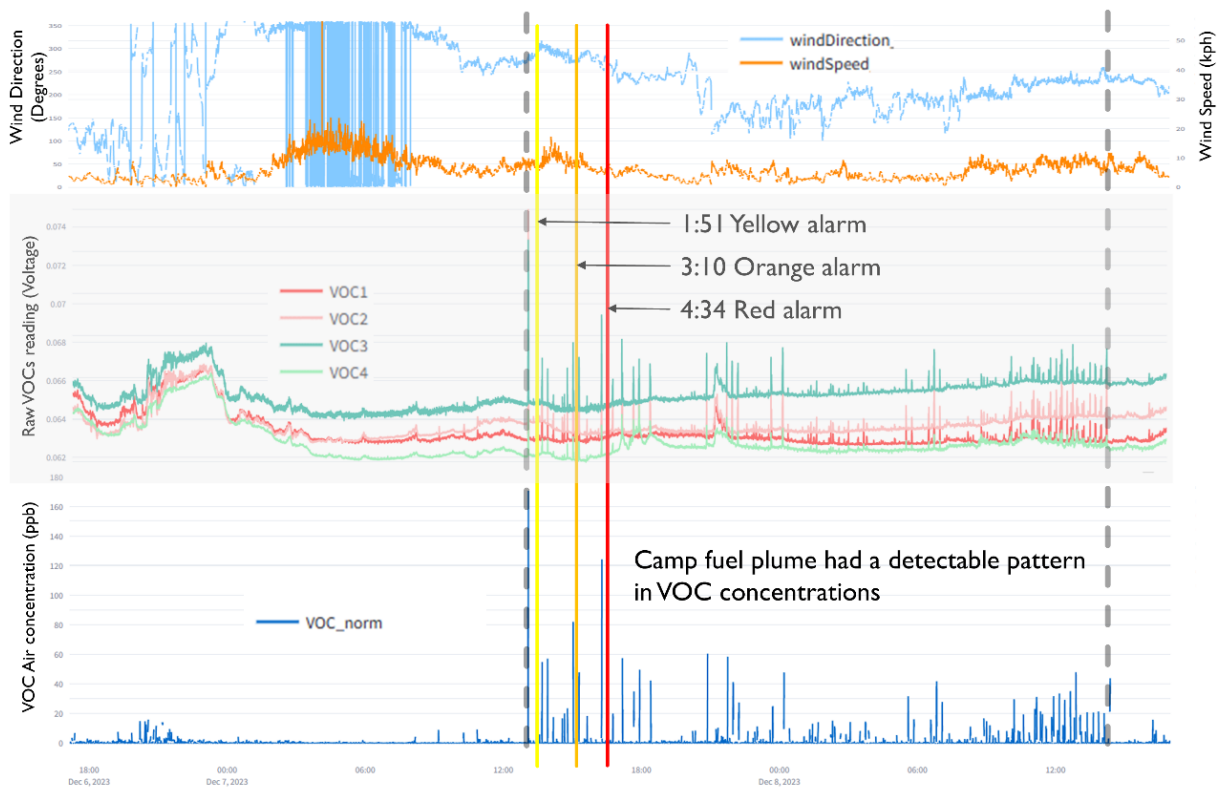
**Figure 3.9 Test 2: Airdar Summary of Alarm Status**

Figure 3.9 shows a summary of data produced by Airdar indicating the wind conditions, the raw sensor data, the processed VOC concentration data, and the times that alarms were generated.

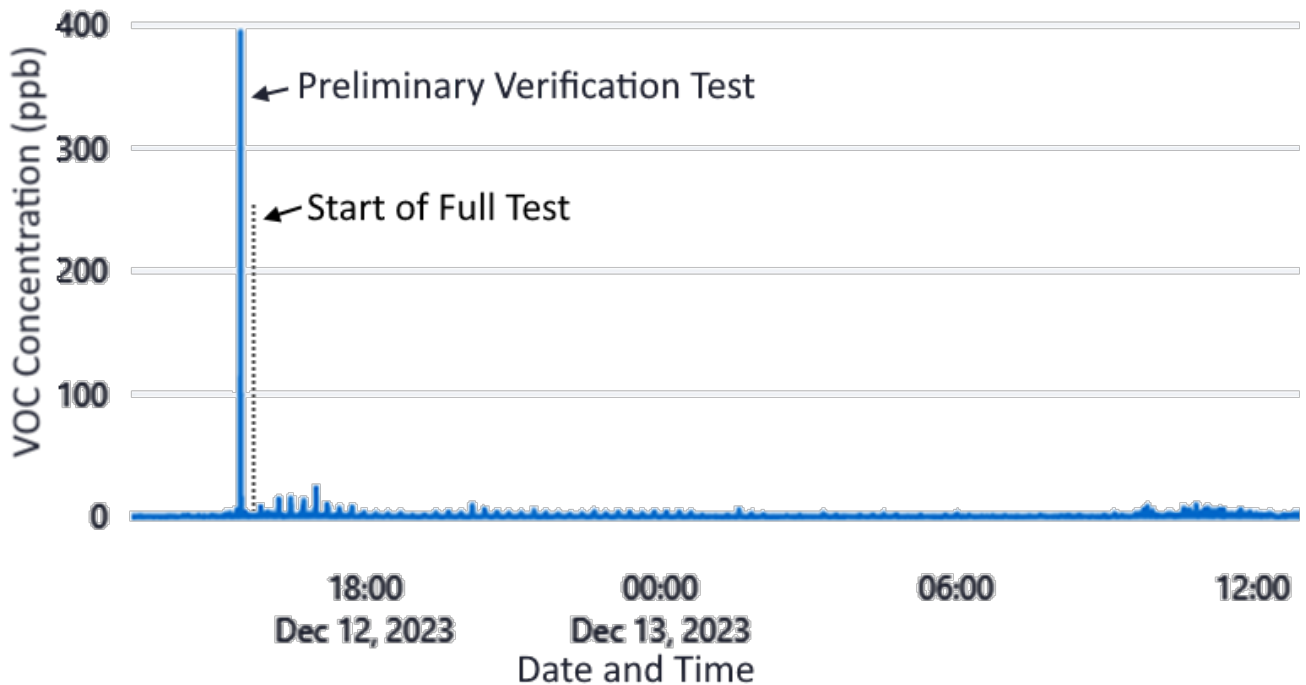
**Figure 3.10 VOC Concentration for Preliminary Test with AWB**

For Test 3, the test fluid was AWB. Prior to performing the full test, a verification that the sensors would respond to the volatiles was performed. The System was configured to draw air only from a single inlet for the preliminary verification. A 20 L open drum of AWB was placed immediately adjacent to the operating inlet, which resulted in a strong response from the sensor (see Figure 3.10), indicating that the full test could proceed.

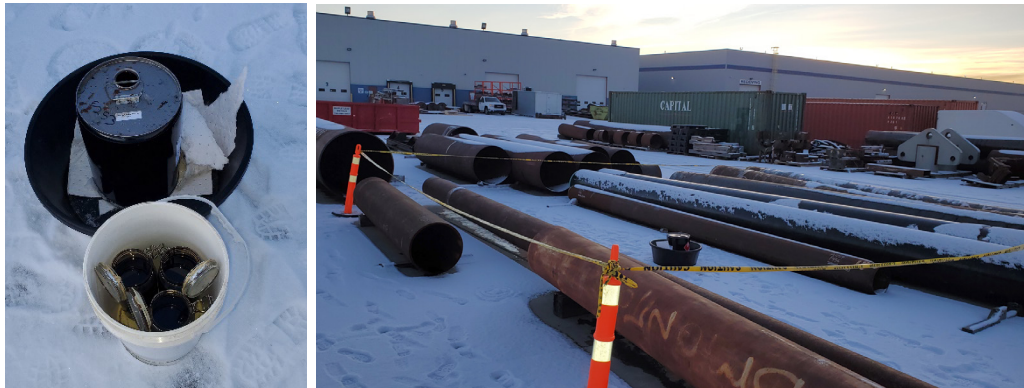
**Figure 3.11 Photographs of Test 3 Configuration**

The full Test 3 was performed by placing a 20 L open drum and three open 2 L jars of AWB in the C-FER yard (see Figure 3.11). The drum had a standard 2-in bung, which resulted in a limited area for vaporization of the volatiles. The jars each had an opening of approximately 3 in. As this was a fully open test, Airdar was informed where and when the simulated spill was performed. The test was monitored but alarms were not active during this test.

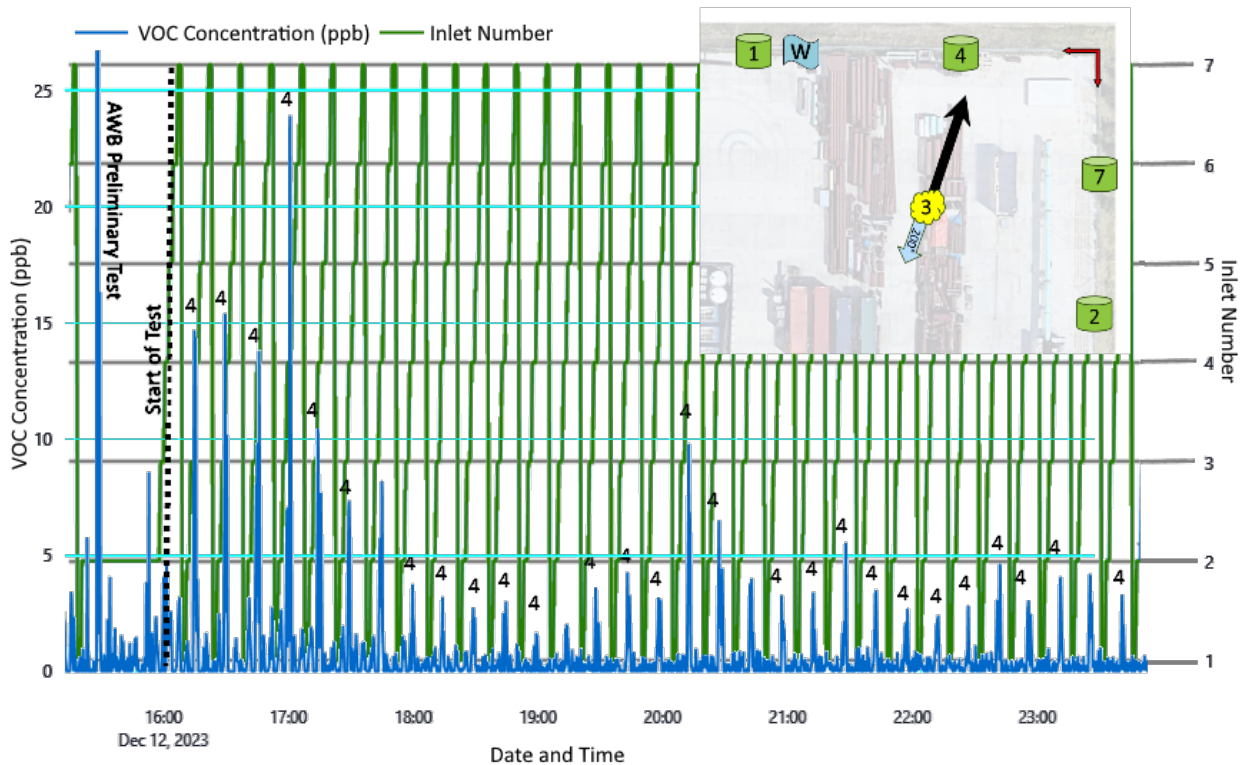
**Figure 3.12 Test 3: VOC and Wind Conditions with Sensor Inlet Numbers and Inset Map of Sensor Locations at Start Time**

During the start of the test period, the wind direction was primarily from 200° (SSW) and was directed towards Inlet 4. Figure 3.12 shows the VOC concentrations recorded during the start of the test period. There were very clear signals from Inlet 4 for several hours. As discussed previously, a leak would continue to supply fresh un-weathered product, thereby increasing the available detectable VOCs. Additionally, the exposed surface area of the fluid would typically be considerably larger and be agitated by the active leak, leading to increased available detectable VOCs.

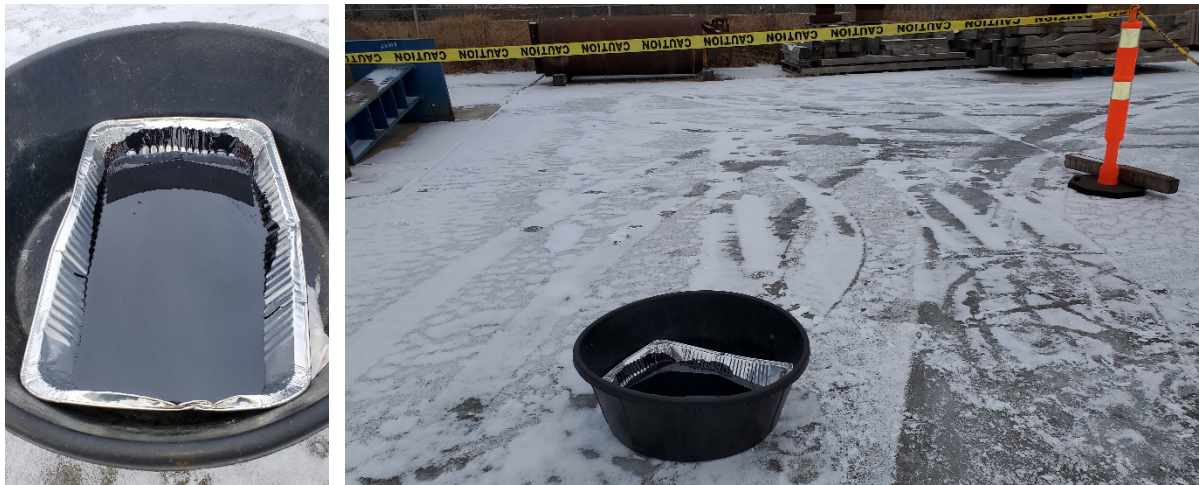
**Figure 3.13 Photographs of Test 4 Configuration**

Test 4 was a blind test where Airdar was not informed of the day, time, or exact location of the simulated spill. During this test, the alarms were active. Like the previous white gas tests, an open tray containing 5 L of AWB was placed in the yard (see Figure 3.13). After 24 hours with no alarms from the System, an additional 5 L was added to the tray. Figure 3.14 shows the VOC concentration, wind direction, and the location of the simulated spill in the yard. The increased VOC levels also did not produce any alarms because either the levels were not sustained or the sensor inlet and wind direction indicated offsite sources. During this test, the wind direction varied between 100° and 200° at 15 to 20 kph. This direction may have caused any potential plume to pass between the sensor inlets.
